DEPARTMENT OF TRANSPORTATION**DIVISION OF ENGINEERING SERVICES**

Contract #: 04-0120F4Cty: SF/ALA Rte: 80 PM: 13.2/13.9File #: 69.28**WELDING INSPECTION REPORT****Resident Engineer:** Pursell, Gary**Address:** 333 Burma Road**City:** Oakland, CA 94607**Report No:** WIR-001636**Date Inspected:** 18-Feb-2008**Project Name:** SAS Superstructure**OSM Arrival Time:** 800**Prime Contractor:** American Bridge/Fluor Enterprises, a JV**OSM Departure Time:** 1730**Contractor:** Zhenhua Port Machinery Company, Ltd (ZPMC), Changxing Island **Location:** Shanghai, China**CWI Name:** See Below**CWI Present:** Yes No**Inspected CWI report:** Yes No N/A**Rod Oven in Use:** Yes No N/A**Electrode to specification:** Yes No N/A**Weld Procedures Followed:** Yes No N/A**Qualified Welders:** Yes No N/A**Verified Joint Fit-up:** Yes No N/A**Approved Drawings:** Yes No N/A**Approved WPS:** Yes No N/A**Delayed / Cancelled:** Yes No N/A**Bridge No:** 34-0006**Component:** Tower and OBG Fabrication**Summary of Items Observed:**

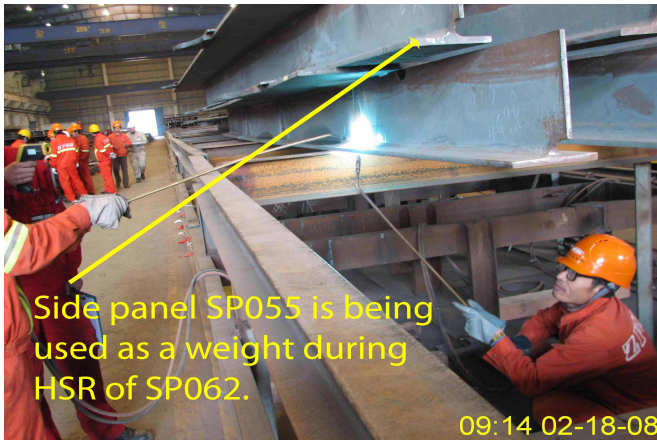
The QA Inspector observed ZPMC personnel perform heat straightening of OBG side plate SP062 as directed by HSR1(B)-192. This HSR has been approved by Mr. Hu Gang on 01-28-2008. The QA inspector observed Quality Control Inspector Mr. Duan Yabing monitoring the heat temperature using a laser indicating device and the maximum temperature that Mr. Yabing had recorded is 543°C. ZPMC normally uses a large metal counterweight to apply a downward force on the plate that is being flame straightened and today ZPMC is using side panel SP055 assembly instead of the normally used counterweight on top of SP062 during this flame straightening. Note: the sketch on the HSR document shows a counterweight being used instead of a second side plate assembly. See the photograph below for additional information.
